**DEPARTMENT OF TRANSPORTATION**

Contract #: 04-0120F4Cty: SF/ALA Rte: 80 PM: 13.2/13.9File #: 69.28**WELDING INSPECTION REPORT****Resident Engineer:**Pursell, Gary**Address:** 333 Burma Road**City:** Oakland, CA 94607**Report No:** WIR-002588**Date Inspected:** 25-Apr-2008**Project Name:** SAS Superstructure**OSM Arrival Time:** 630**Prime Contractor:** American Bridge/Fluor Enterprises, a JV**OSM Departure Time:** 1730**Contractor:** Zhenhua Port Machinery Company, Ltd (ZPMC), Changxing Island **Location:** Shanghai, China**CWI Name:** See below**CWI Present:** Yes No**Inspected CWI report:** Yes No N/A**Rod Oven in Use:** Yes No N/A**Electrode to specification:** Yes No N/A**Weld Procedures Followed:** Yes No N/A**Qualified Welders:** Yes No N/A**Verified Joint Fit-up:** Yes No N/A**Approved Drawings:** Yes No N/A**Approved WPS:** Yes No N/A**Delayed / Cancelled:** Yes No N/A**Bridge No:** 34-0006**Component:** OBG/Tower**Summary of Items Observed:**

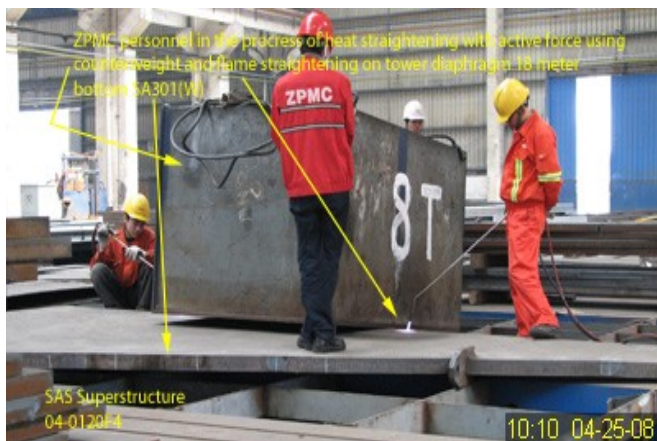
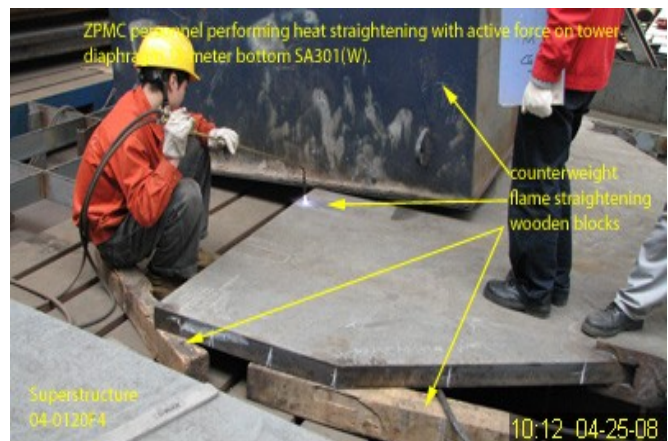
ABF has allowed ZPMC to perform Heat Straightening (HS) with active force on 04-25-2008. The use of counter weights is not a step in the ABF/ZPMC approved fabrication plan for the Tower Diaphragm plates. The observed diaphragm plate with this heat straightening method is for the 18 Meter elevation bottom SA301(W). The referencing heat straightening procedure was recorded as ZPMC (HS) Report Number HSR1(T)-516, ZPMC. Also, see incident report written on 04-25-08.

The following digital photograph below illustrates observation of the activities being performed.
